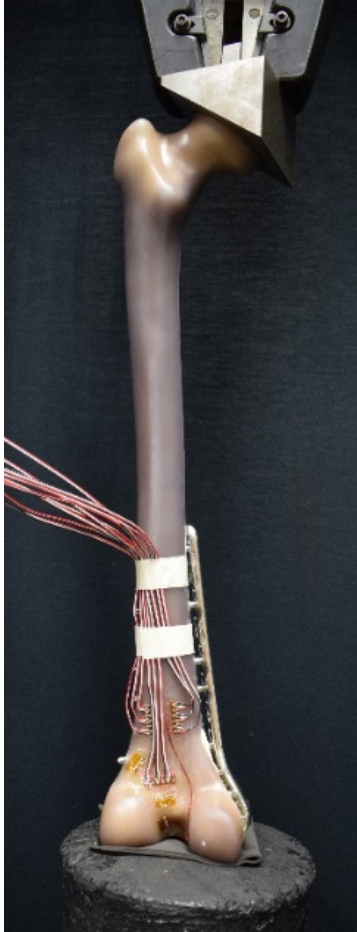
Figure 3. Biomechanical testing setup with strain gauges attached to the posterior distal femur at locations of greatest stress concentration as determined by photostress analysis.
